Whirl Wind Propellers

SERVICE LETTER

SL-GA200L-021213

TO: ALL OWNERS / OPERATORS OF AFFECTED PROPELLERS
SUBJECT: HUB CRACKING
DATE: FEBRUARY 12, 2013

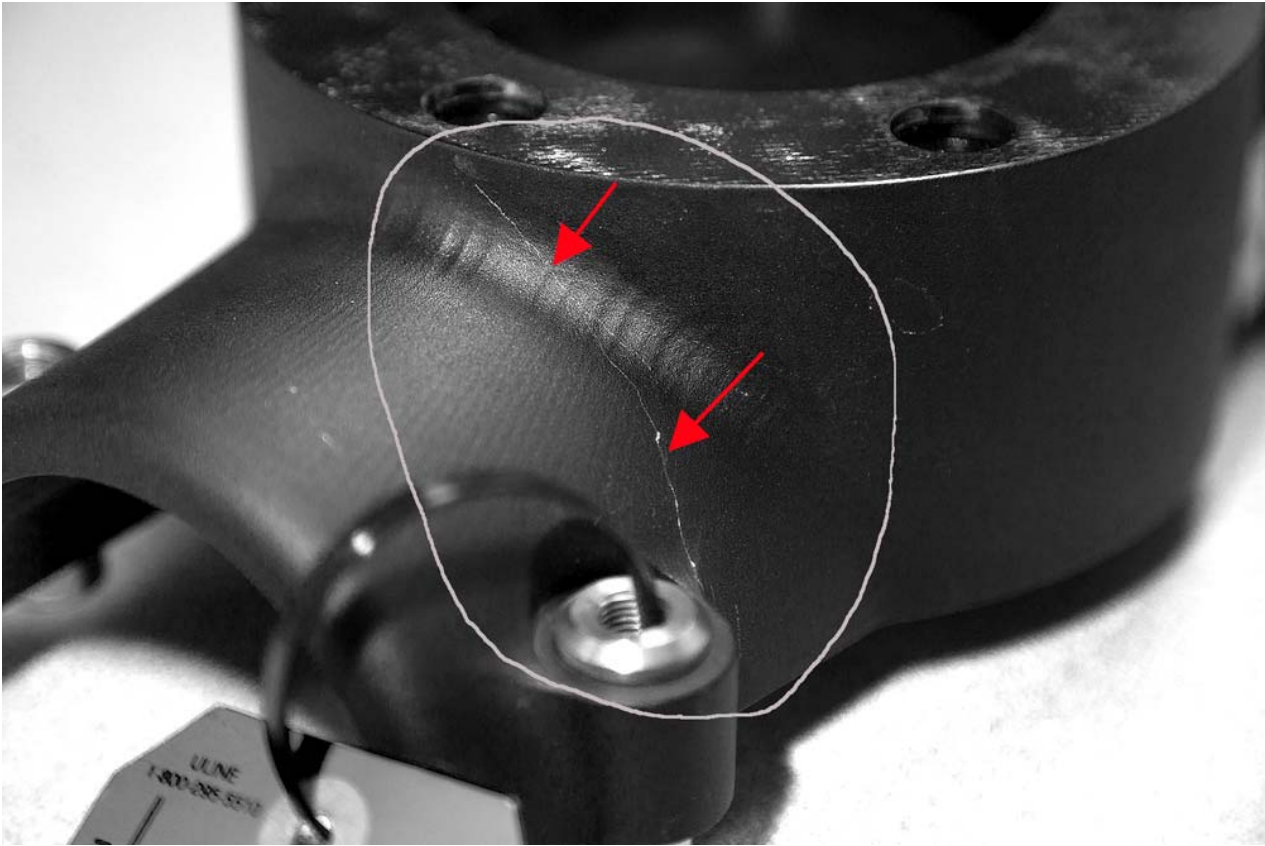
REASON: Upon routine inspection of a GA200L-78 propeller, the propeller hub was found to have a crack on the aft side. The propeller was installed on ECI-0340 engine, with 78" diameter blades. The propeller had 84 hours total time. The hub crack found so far has been an isolated case.

It is worth noting that if the crack had continued to propagate completely around the hub-half, neither the blade nor the hub part would have separated from the hub assembly. The crack was located in the outer retention ring (towards the blade), with the inner retention ring unaffected. The inner retention ring is sufficiently strong to retain the propeller blade.

EXAMPLE OF HUB CRACK FOUND ON GA200L 78"

1. Remove spinner and inspect hub with magnifying glass for any sign of cracking as depicted in picture (see page 2)
2. If no crack is detected return to service and inspect hub in 10hr intervals.
3. If crack is detected contact WhirlWind Propellers. Propeller hub is no longer airworthy.
4. Recommend inspection procedure until further notice
