Whirl Wind Propellers
SERVICE LETTER

SL-300-3B_72-091620: 300 Series Propeller Hubs

SUBJECT: PISTON O-RING UN-SEATING IN HUB CAUSING OIL LEAK, LOSS OF OIL PRESSURE, AND POTENTIAL LOSS OF PITCH CONTROL

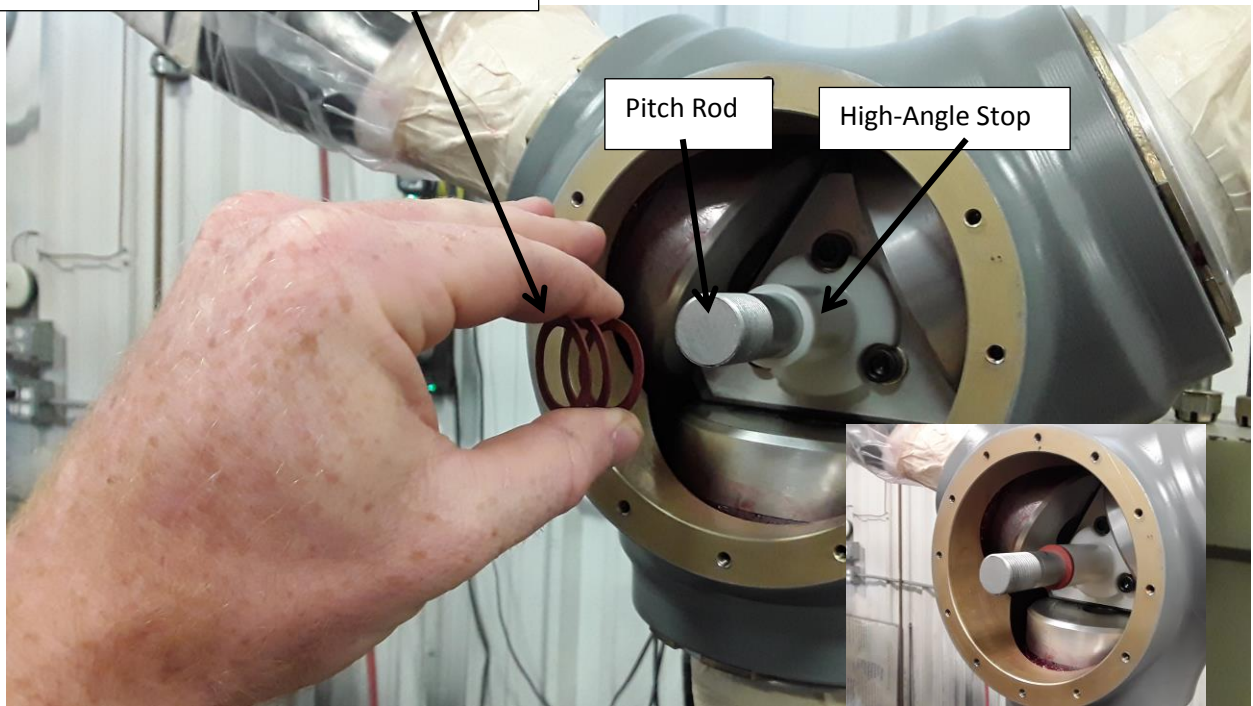
REASON: The 300 Series propeller hubs may allow the piston O-ring to extend beyond the cylinder at the high-pitch position resulting in immediate, heavy oil leakage and O-ring damage.

Step 5. Slide 3 Fiber Washers onto Pitch Rod So they butt up against the High-Angle Stop
