# Whirl Wind Propellers

## SERVICE LETTER

SL-GA-J2B-012714

**TO:** ALL OWNERS / OPERATORS OF AFFECTED PROPELLERS  
**SUBJECT:** BLADE CLAMP BOLT CRACK  
**DATE:** JANUARY 27, 2014

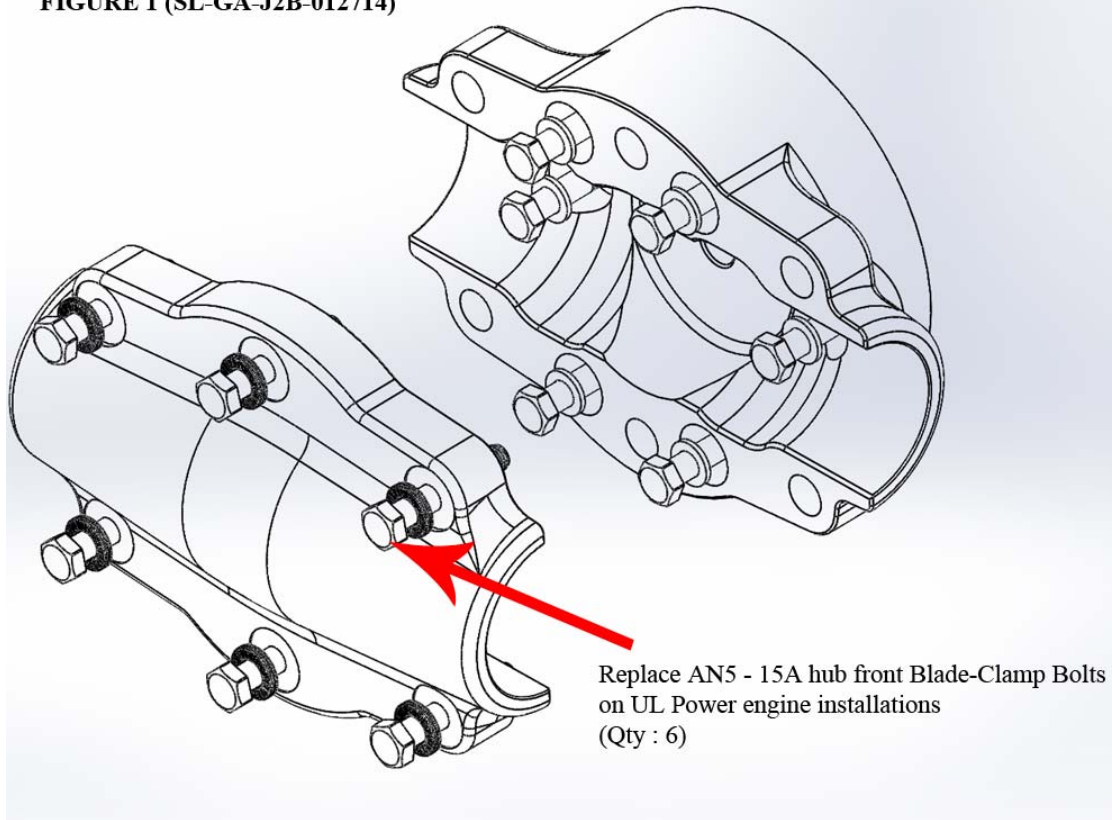
**FIGURE 1 (SL-GA-J2B-012714)**

**REASON:** Upon routine inspection of a **GA-J2B** propeller in the affected Serial Number range, installed on a UL350is engine, one of the propeller hub blade-clamp bolts (AN5-15A) was found to have a crack. The propeller was installed on a UL-350is engine, with 65" diameter blades. The propeller had 300+ hours total time. The bolt crack found so far has been an isolated case.

**ACTION:** *Reference Figure 1 on Page 2*

Recommend replacement of all 6 front hub blade-clamp bolts (AN5-15A) at time of every Annual or every 100 hrs, whichever occurs first.

Mandatory replacement of all 6 front hub blade-clamp bolts (AN5-15A) before next flight.

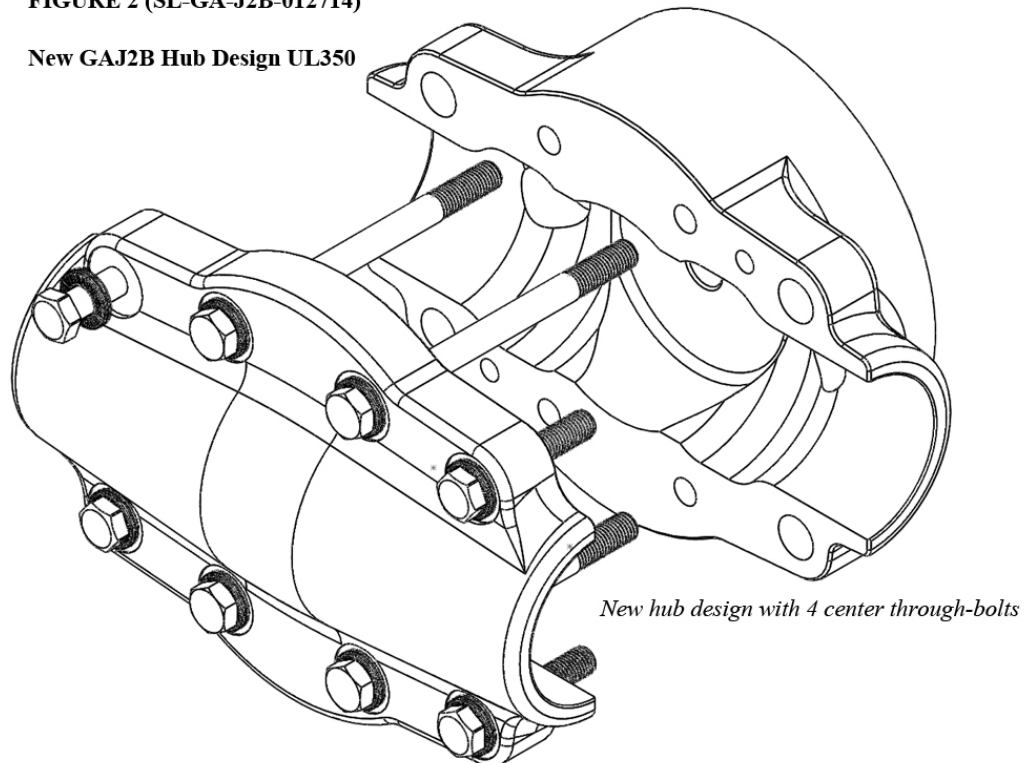
**FIGURE 2 (SL-GA-J2B-012714)**

**New GAJ2B Hub Design UL350**

Optional: Owners of affected propellers may trade-in affected propeller hub and purchase new style UL350 hub (See Figure 2) at reduced cost. Contact WhirlWind Propellers directly for pricing.

**2015 Update: Mandatory hub replacement for installations on UL350 engines**
