Whirl Wind Propellers

SERVICE LETTER

SL-GA-J2B-040115

TO: ALL OWNERS / OPERATORS OF AFFECTED PROPELLERS
SUBJECT: HUB BOLT CRACK
DATE: APRIL 2, 2015

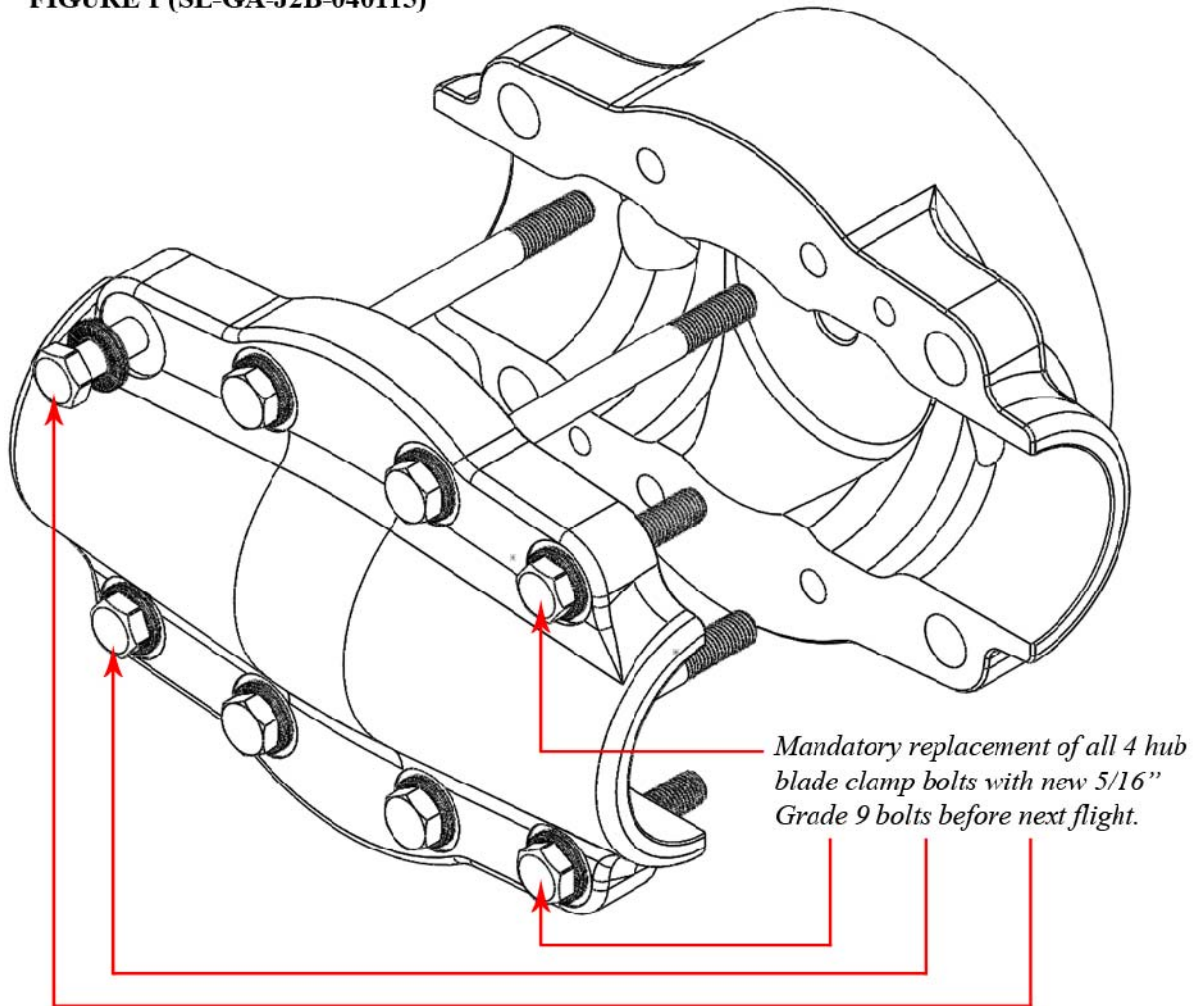
FIGURE 1 (SL-GA-J2B-040115)

REASON: Upon routine inspection of a **GA-J2B** installed on a UL350is engine, the propeller hub blade clamp bolts (5/16") were found to have cracked. The propeller was installed on a UL-350is engine, with 65" diameter blades. The bolt crack found so far has been an isolated case.

1. Mandatory replacement of all 4 hub blade clamp bolts with new 5/16" Grade 9 bolts before next flight.
2. Bolt Torque on all hub bolts must be checked every 50 hours. Hub Blade Clamp Bolts are recommended to be replaced with new hardware during each annual inspection.
