Whirl Wind Propellers Corporation
1800 Joe Crosson Dr., El Cajon, CA 92020
619-562-3725

SERVICE LETTER

SL-400C-020624

SUBJECT: REPLACEMENT OF MCCAULEY COUNTERWEIGHTS ON ALL 400 SERIES PROPELLERS.

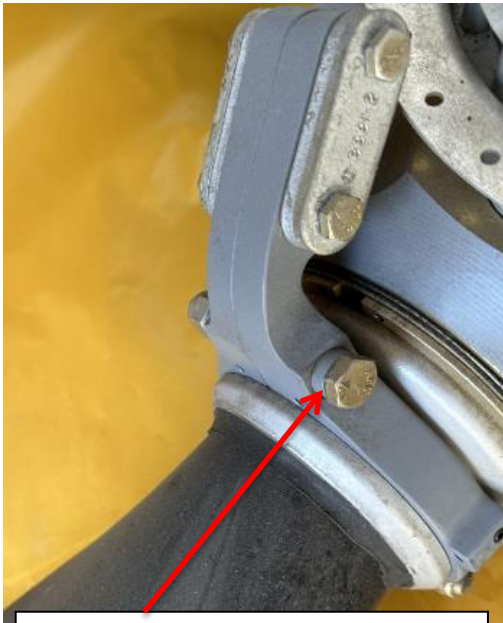
Figure 1

REASON: Crack has been found on McCauley Counterweight.

**McCauley Counterweights
(to be replaced)**

Hexagonal Head Bolts used to identify McCauley Counterweights.

- 1) Remove McCauley Counterweights and SCRAP.
- 2) Install new Counterweights as per Instructions in Counterweight Kit.

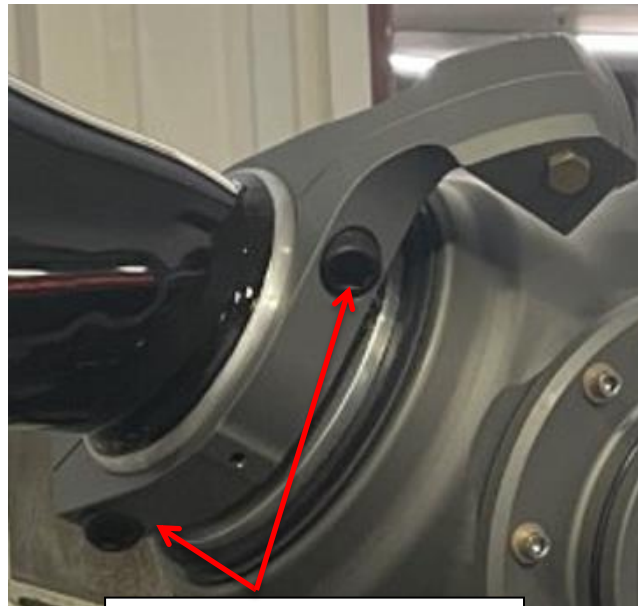
Figure 2

**Replace with Whirl Wind
Counterweight Design**

Allen Head Bolts used in Whirl Wind Counterweight Design.

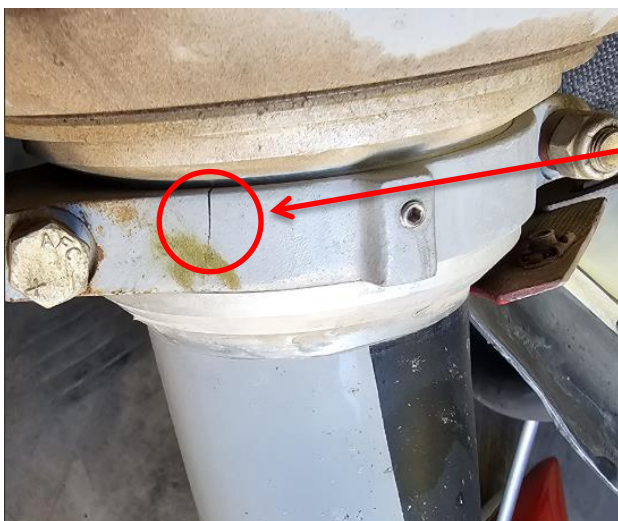
Figure 3

Clean and inspect Counterweight Clamps with 10X Magnifying glass for possible cracks.

If cracks are found, the propeller is not airworthy. (DO NOT FLY)

If no cracks are found, replace counterweights within the next 5 flight hours.
