WHIRLWIND PROPELLER
ALERT SERVICE BULLETIN
TRANSMITTAL SHEET
WW-ASB-61-001
Hub Inspection

April 21, 2025

WHIRLWIND PROPELLER
ALERT SERVICE BULLETIN
WW-ASB-61-001
Hub Inspection

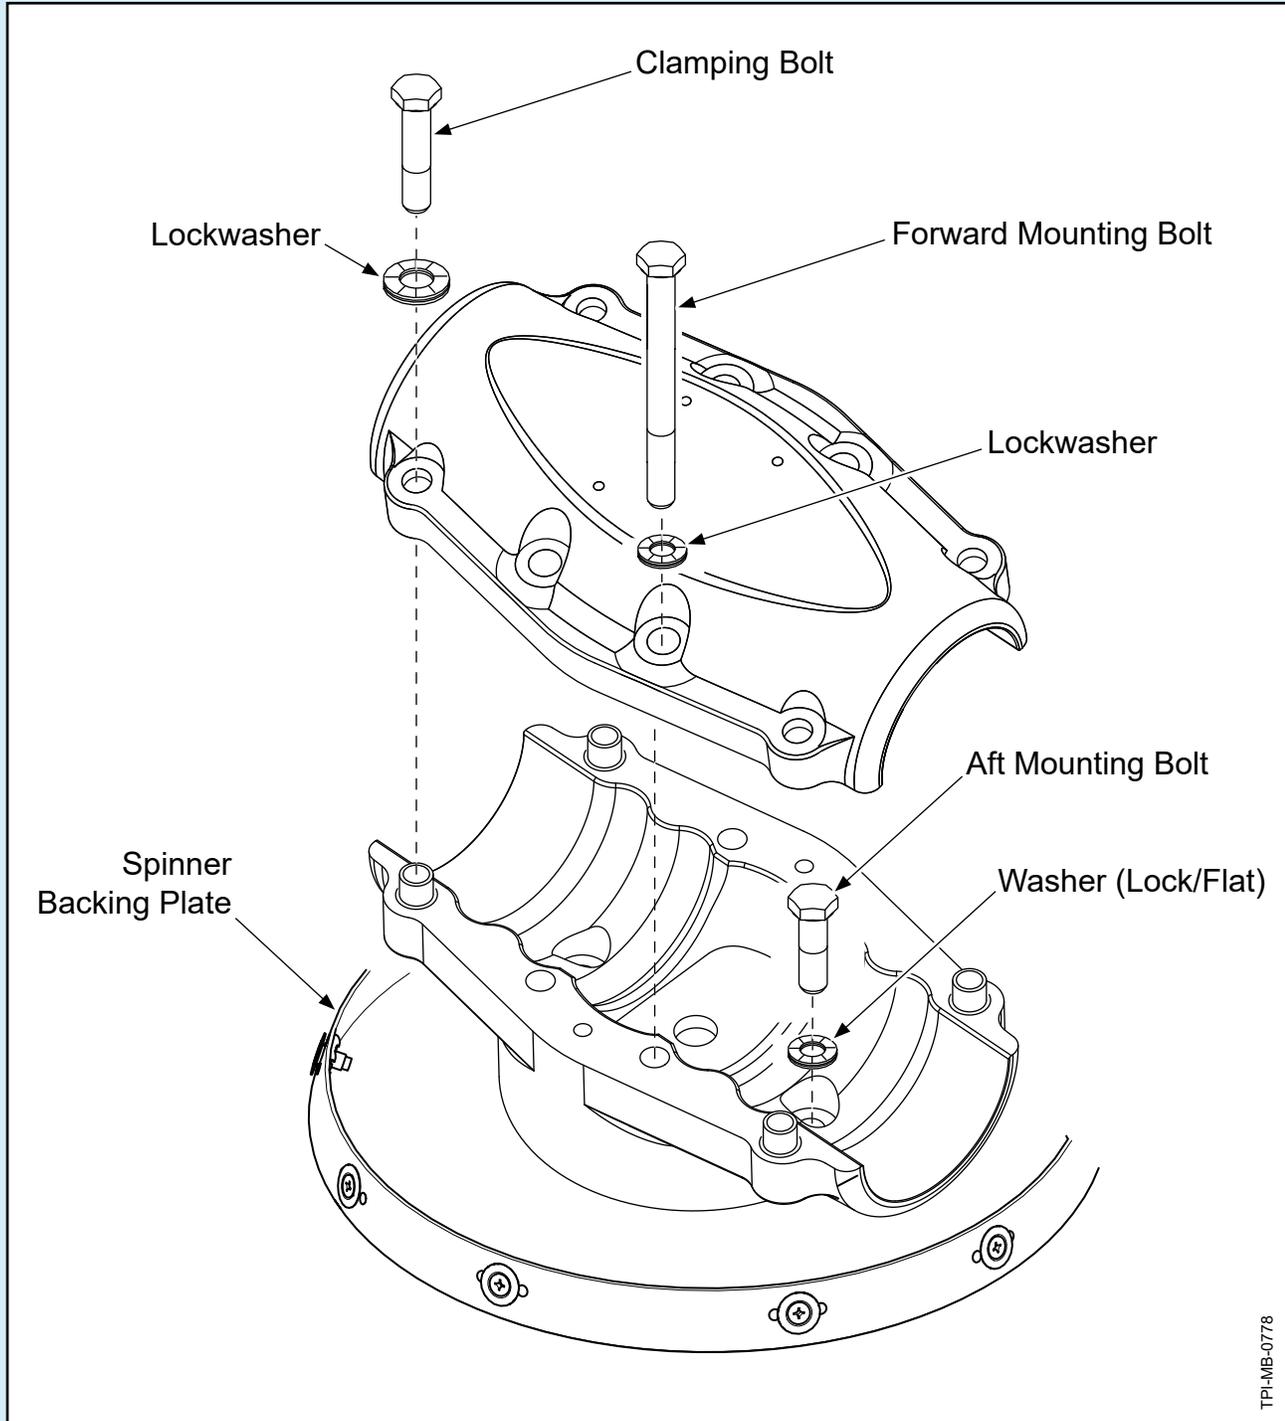
Hub Clamping/Mounting Bolts
Figure 1

- (1) Whirlwind Propeller has received reports of cracking around the bolt holes in the hubs on affected propellers.
- (2) Whirlwind Propeller has received reports of broken hub clamping bolts on affected propellers.
- (3) Whirlwind Propeller has received reports of torque loss on the aft mounting bolts on affected propellers.

- (3) Remove the hub clamping/mounting hardware in accordance with Figure 1 and the following steps:
 - (a) Remove four clamping bolts/lockwashers, and four forward mounting bolts/lockwashers from the hub.
 - (b) Remove the forward hub half.
 - (c) Remove the blade assemblies.
 - (d) Remove two aft mounting bolts and washers (lock/flat).
 - (e) Remove the aft hub half from the aircraft.
- (4) Examine the bolts and washers for cracks or other damage.
 - (a) Discard any cracked, damaged, or excessively worn bolts/washers.
 - 1 Contact Whirlwind Propeller for information about replacement hardware.

- (1) Remove the all of the hub clamping/mounting bolts and washers.
 - (a) Discard all of the washers.
- (2) Install new washers on the hub clamping/mounting bolts.
 - (a) Install (and torque) the hub clamping/mounting bolts and washers in accordance with the applicable Whirlwind Propeller Owner's Manual.

- (1) Remove and discard all of the hub clamping/mounting bolts and washers.
- (2) Install new hub clamping/mounting bolts and washers.
 - (a) Install (and torque) the hub clamping/mounting bolts and washers in accordance with the applicable Whirlwind Propeller Owner's Manual.

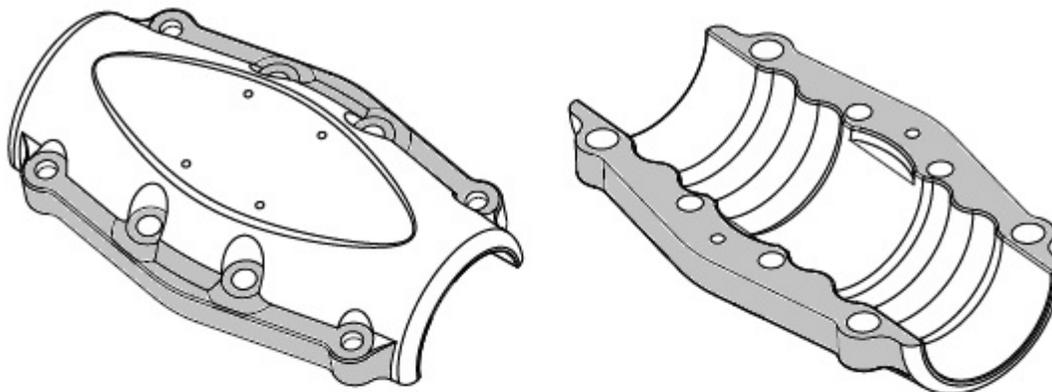
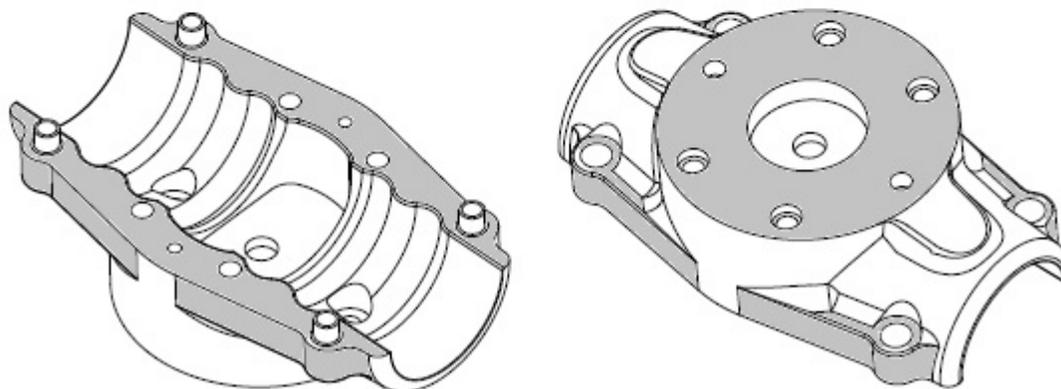
Hub Inspection
Figure 2

CAUTION: IN FIELD REPORTS, HUB CRACKING HAS OCCURED ON SURFACES AROUND THE BOLT HOLES. EXAMINE THE SHADED AREAS CLOSELY.

CAUTION: IN FIELD REPORTS, HUB CRACKING HAS OCCURED ON SURFACES AROUND THE BOLT HOLES. EXAMINE THESE AREAS CLOSELY.

- (5) Carefully examine all hub surfaces for cracks, fretting, or other damage. Refer to Figure 2.
 - (a) If no cracks, fretting, or other damage is found, go to Step (6).
 - (b) If cracks, fretting, or other damage is found, retire the damaged hub.
 - 1 A new or serviceable hub must be installed before further flight.
 - 2 Contact Whirlwind Propeller to report the cracked/damaged hub.

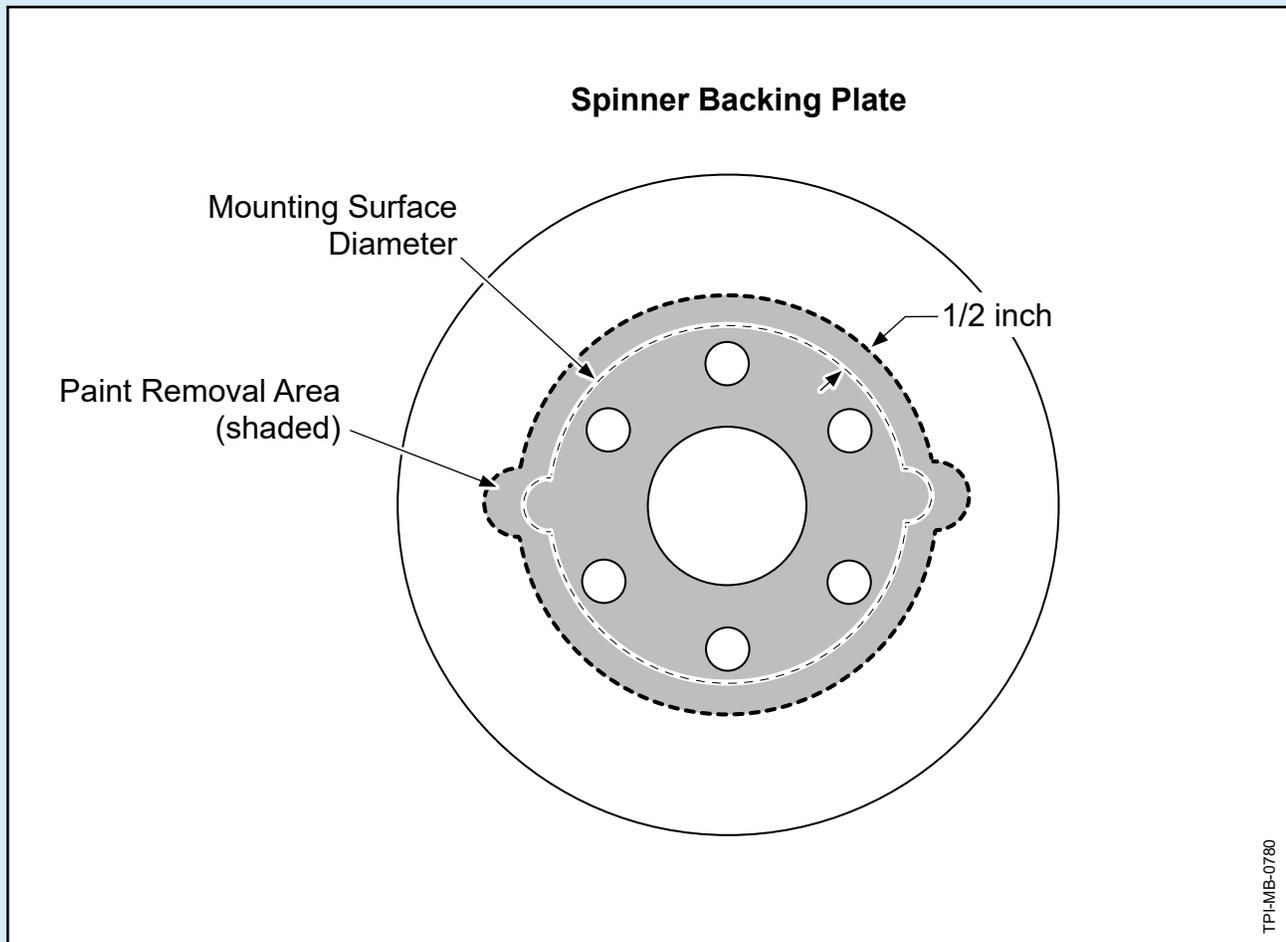
Paint Removal
Figure 3

CAUTION: PAINT IS NOT PERMITTED ON THE HUB/ENGINE MOUNTING SURFACES OF THE SPINNER BACKING PLATE.

- (1) Examine both sides of the spinner backing plate for paint on the mounting surfaces (hub/engine). Refer to Figure 3.
 - (a) If the mounting surface is painted, remove the paint in accordance with the "Paint Removal" procedure in this section.
 - 1 After removing the paint from the mounting surface(s), reinstall the spinner backing plate.
 - (b) If the mounting surfaces are not painted, reinstall the spinner backing plate.

- (1) Locate the diameter of the hub/engine mounting surface.
- (2) Mark the paint removal area at least 1/2 inch larger than the diameter of the mounting surface as shown in Figure 3.

- (3) Using 220 grit sandpaper or equivalent, remove the paint in the marked area.
