**WHIRLWIND PROPELLER**  
**ALERT SERVICE BULLETIN**  
**TRANSMITTAL SHEET**  
**WW-ASB-61-001**  
**Hub Inspection**

February 17, 2026

**WHIRLWIND PROPELLER**  
**ALERT SERVICE BULLETIN**  
**WW-ASB-61-001**  
**Hub Inspection**

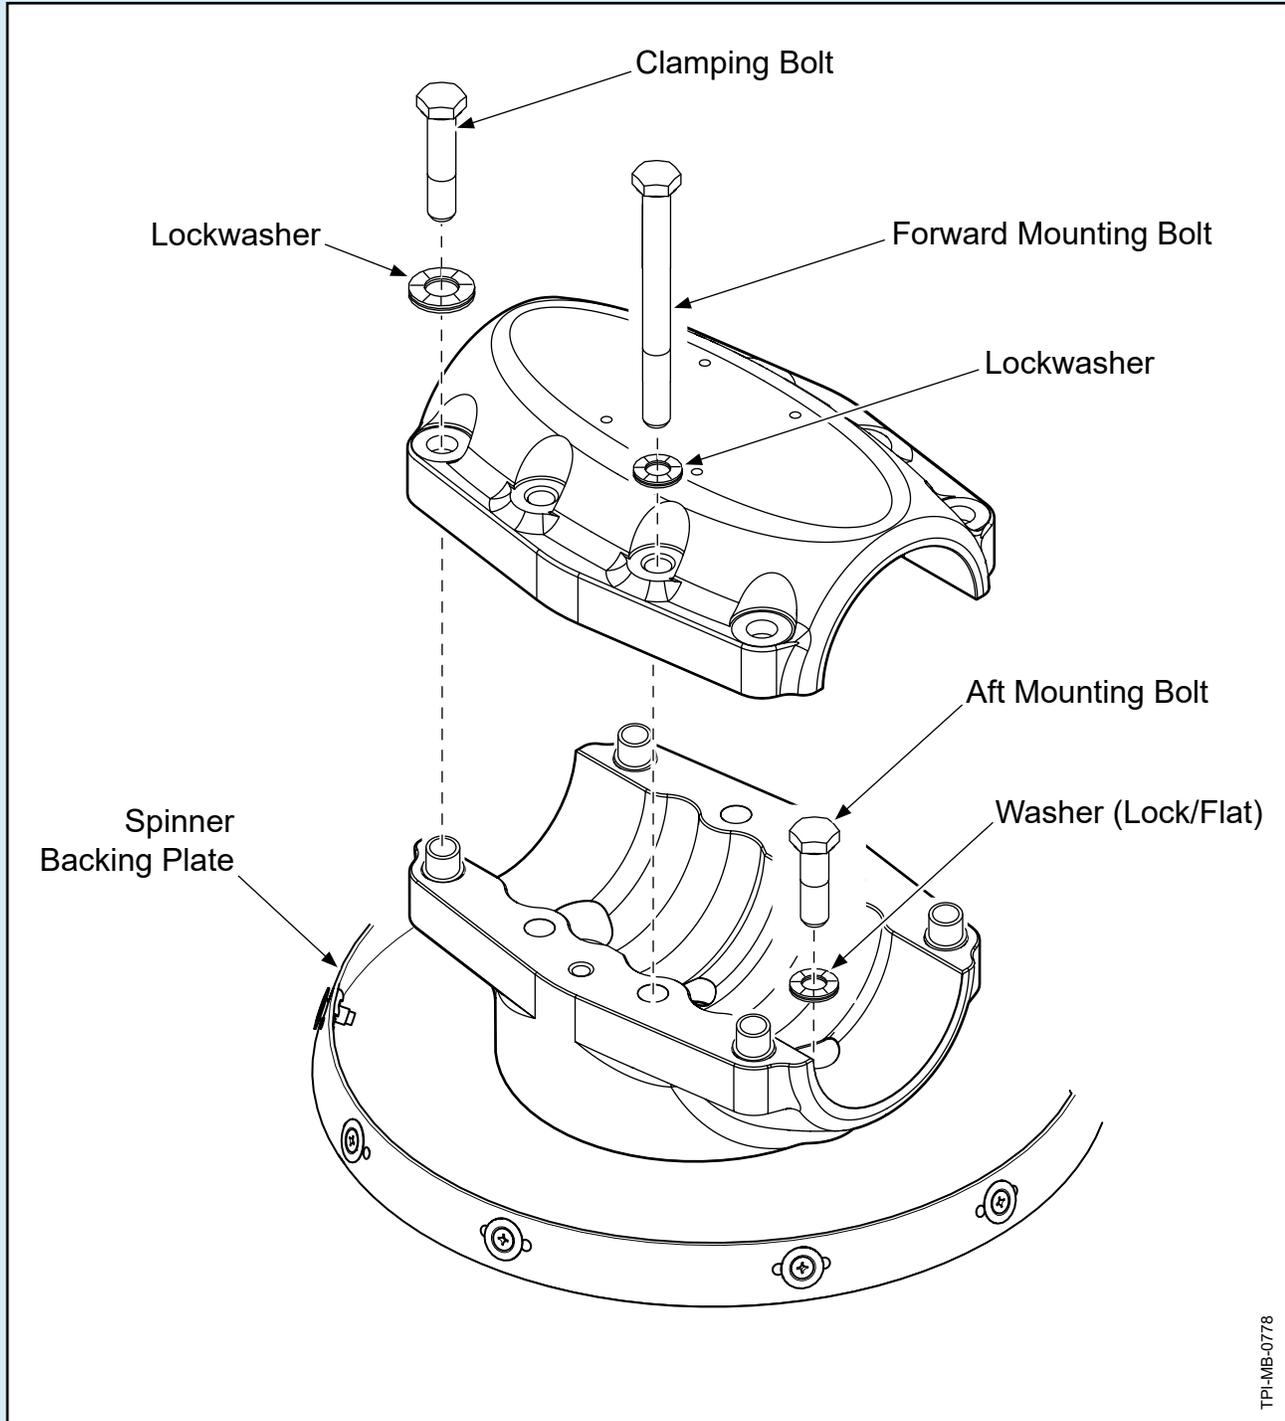
**Hub Clamping/Mounting Bolts**  
**Figure 1**

- (1) Whirlwind Propeller has received reports of cracking around the bolt holes in the hubs on affected propellers.
- (2) Whirlwind Propeller has received reports of broken hub clamping bolts on affected propellers.
- (3) Whirlwind Propeller has received reports of torque loss on the aft mounting bolts on affected propellers.

- (3) Remove the hub clamping/mounting hardware in accordance with Figure 1 and the following steps:
  - (a) Remove four clamping bolts/lockwashers, and four forward mounting bolts/lockwashers from the hub.
  - (b) Remove the forward hub half.
  - (c) Remove the blade assemblies.
  - (d) Remove two aft mounting bolts and washers (lock/flat).
  - (e) Remove the aft hub half from the aircraft.
- (4) Examine the bolts and washers for cracks or other damage.
  - (a) Discard any cracked, damaged, or excessively worn bolts/washers.
    - 1 Contact Whirlwind Propeller for information about replacement hardware.

- (1) Remove the all of the hub clamping/mounting bolts and washers.
  - (a) Discard all of the washers.
- (2) Install new washers on the hub clamping/mounting bolts.
  - (a) Install (and torque) the hub clamping/mounting bolts and washers in accordance with the applicable Whirlwind Propeller Owner's Manual.

- (1) Remove and discard all of the hub clamping/mounting bolts and washers.
- (2) Install new hub clamping/mounting bolts and washers.
  - (a) Install (and torque) the hub clamping/mounting bolts and washers in accordance with the applicable Whirlwind Propeller Owner's Manual.

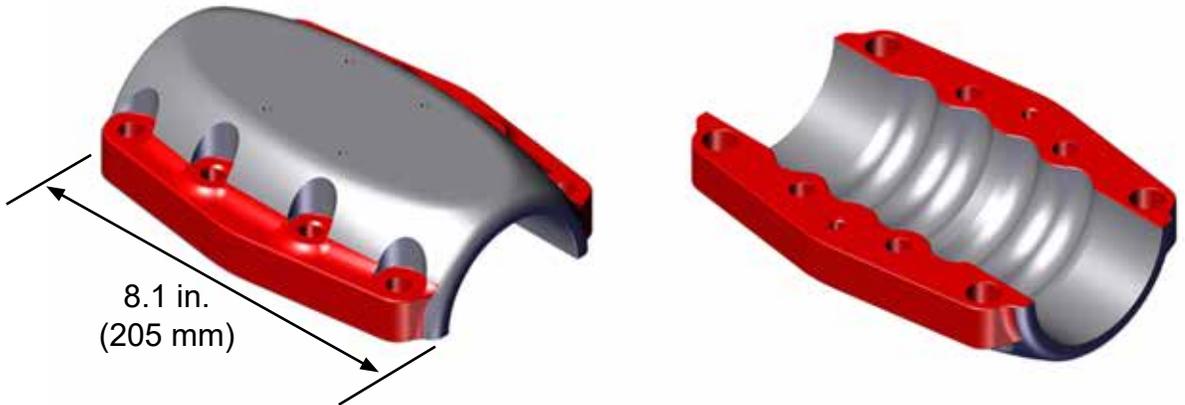
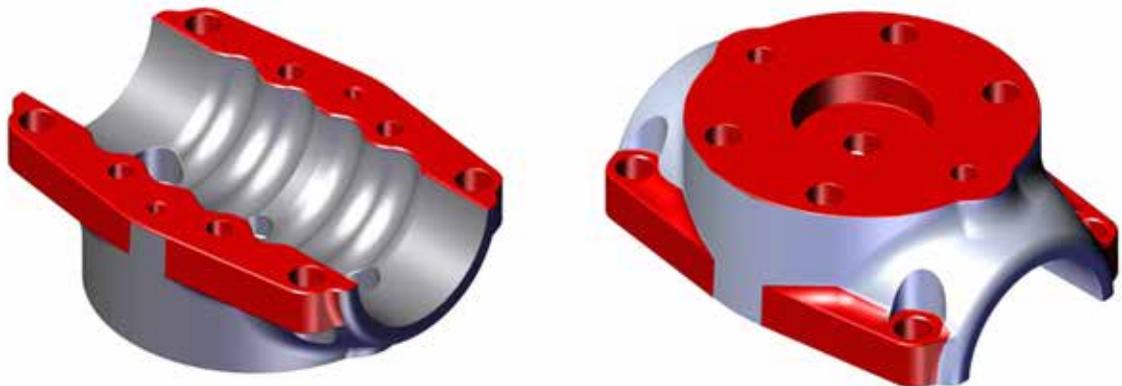
**"Short" Hub Identification/Inspection**  
**Figure 2**

**CAUTION:** IN FIELD REPORTS, HUB CRACKING HAS OCCURED ON SURFACES AROUND THE BOLT HOLES. EXAMINE THE RED SHADED AREAS CLOSELY.

CAUTION: IN FIELD REPORTS, HUB CRACKING HAS OCCURED ON SURFACES AROUND THE BOLT HOLES. EXAMINE THESE AREAS CLOSELY.

- (5) Carefully examine all hub surfaces for cracks, fretting, or other damage. Refer to Figure 2.
  - (a) If no cracks, fretting, or other damage is found, go to Step (6).
  - (b) If cracks, fretting, or other damage is found, retire the damaged hub.
    - 1 A new or serviceable hub must be installed before further flight.
    - 2 Contact Whirlwind Propeller to report the cracked/damaged hub.
